Army Lodging Wellness Recommendation

Fort Gordon - Final Submittal

August 18, 2003

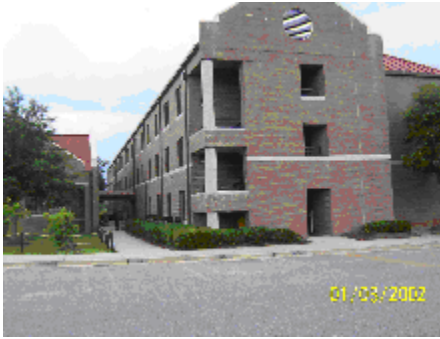
Building 24401 was constructed in 1988. The 37,500 square foot facility contains 93 single room units of which 92 have shared baths. The building is functioning as 93 standard stay rooms.

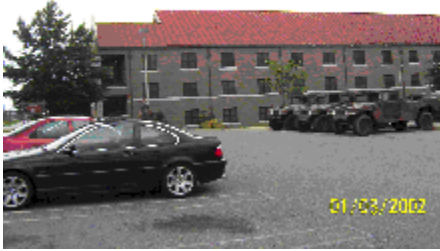
Building 24405 was constructed in 1988. The 37,500 square foot facility contains 93 single room units of which 92 have shared baths. The building is functioning as 93 standard stay rooms.

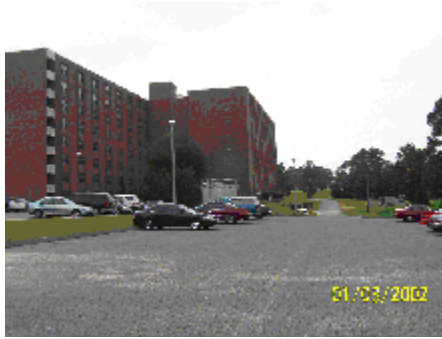
Building 36700

Building 36700, also known as Ring Hall, was constructed in 1972. The 149,320 square foot facility contains 298 lodging rooms with full kitchens functioning as 290 extended stay rooms and 8 family suites.

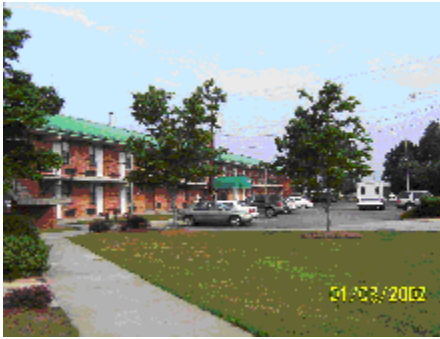
Building 37300

Building 37300, also known as Stinson Guest House, was constructed in 1971. The 30,500 square foot facility contains 74 lodging rooms functioning as 74 standard stay rooms.

- Retain building 37300 for the next 15 – 20 years. A renovation will include all condition assessment deficits, functional criteria for support spaces and upgrading 6 standard rooms to extended stay by adding kitchenettes.

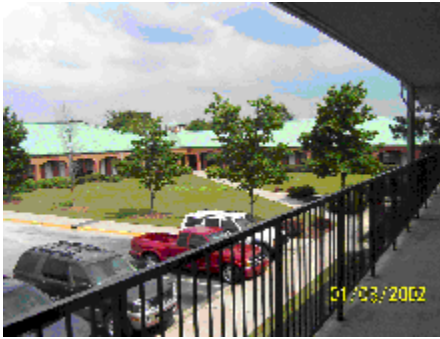
Building 37302

Building 37302, also known as Stinson Guest House Annex, was constructed in 1989. The 16,500 square foot facility contains 32 lodging rooms functioning as 32 standard stay rooms.

- Retain building 37302. A renovation will include all condition assessment deficits, functional criteria for support spaces, and upgrading 29 standard-stay rooms by adding kitchenettes.

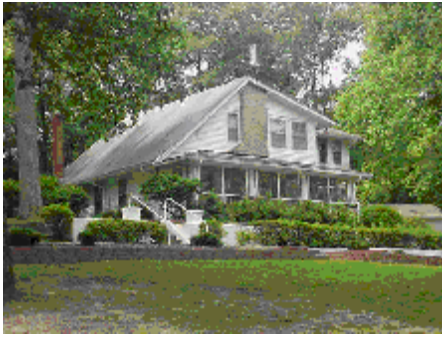
Building QTR#6 was constructed in 1931. The 2,410 square foot facility contains a DVQ. The building is functioning as a family suite for high ranking visitors.
